Environmental Assessment

**Proposed Sapphire Community Health
Hamilton, Ravalli County, Montana**

**HRSA-ARP-Capital-C8E
Grant No. C8ECS44582**

WCEC Project No. 21-14013-70

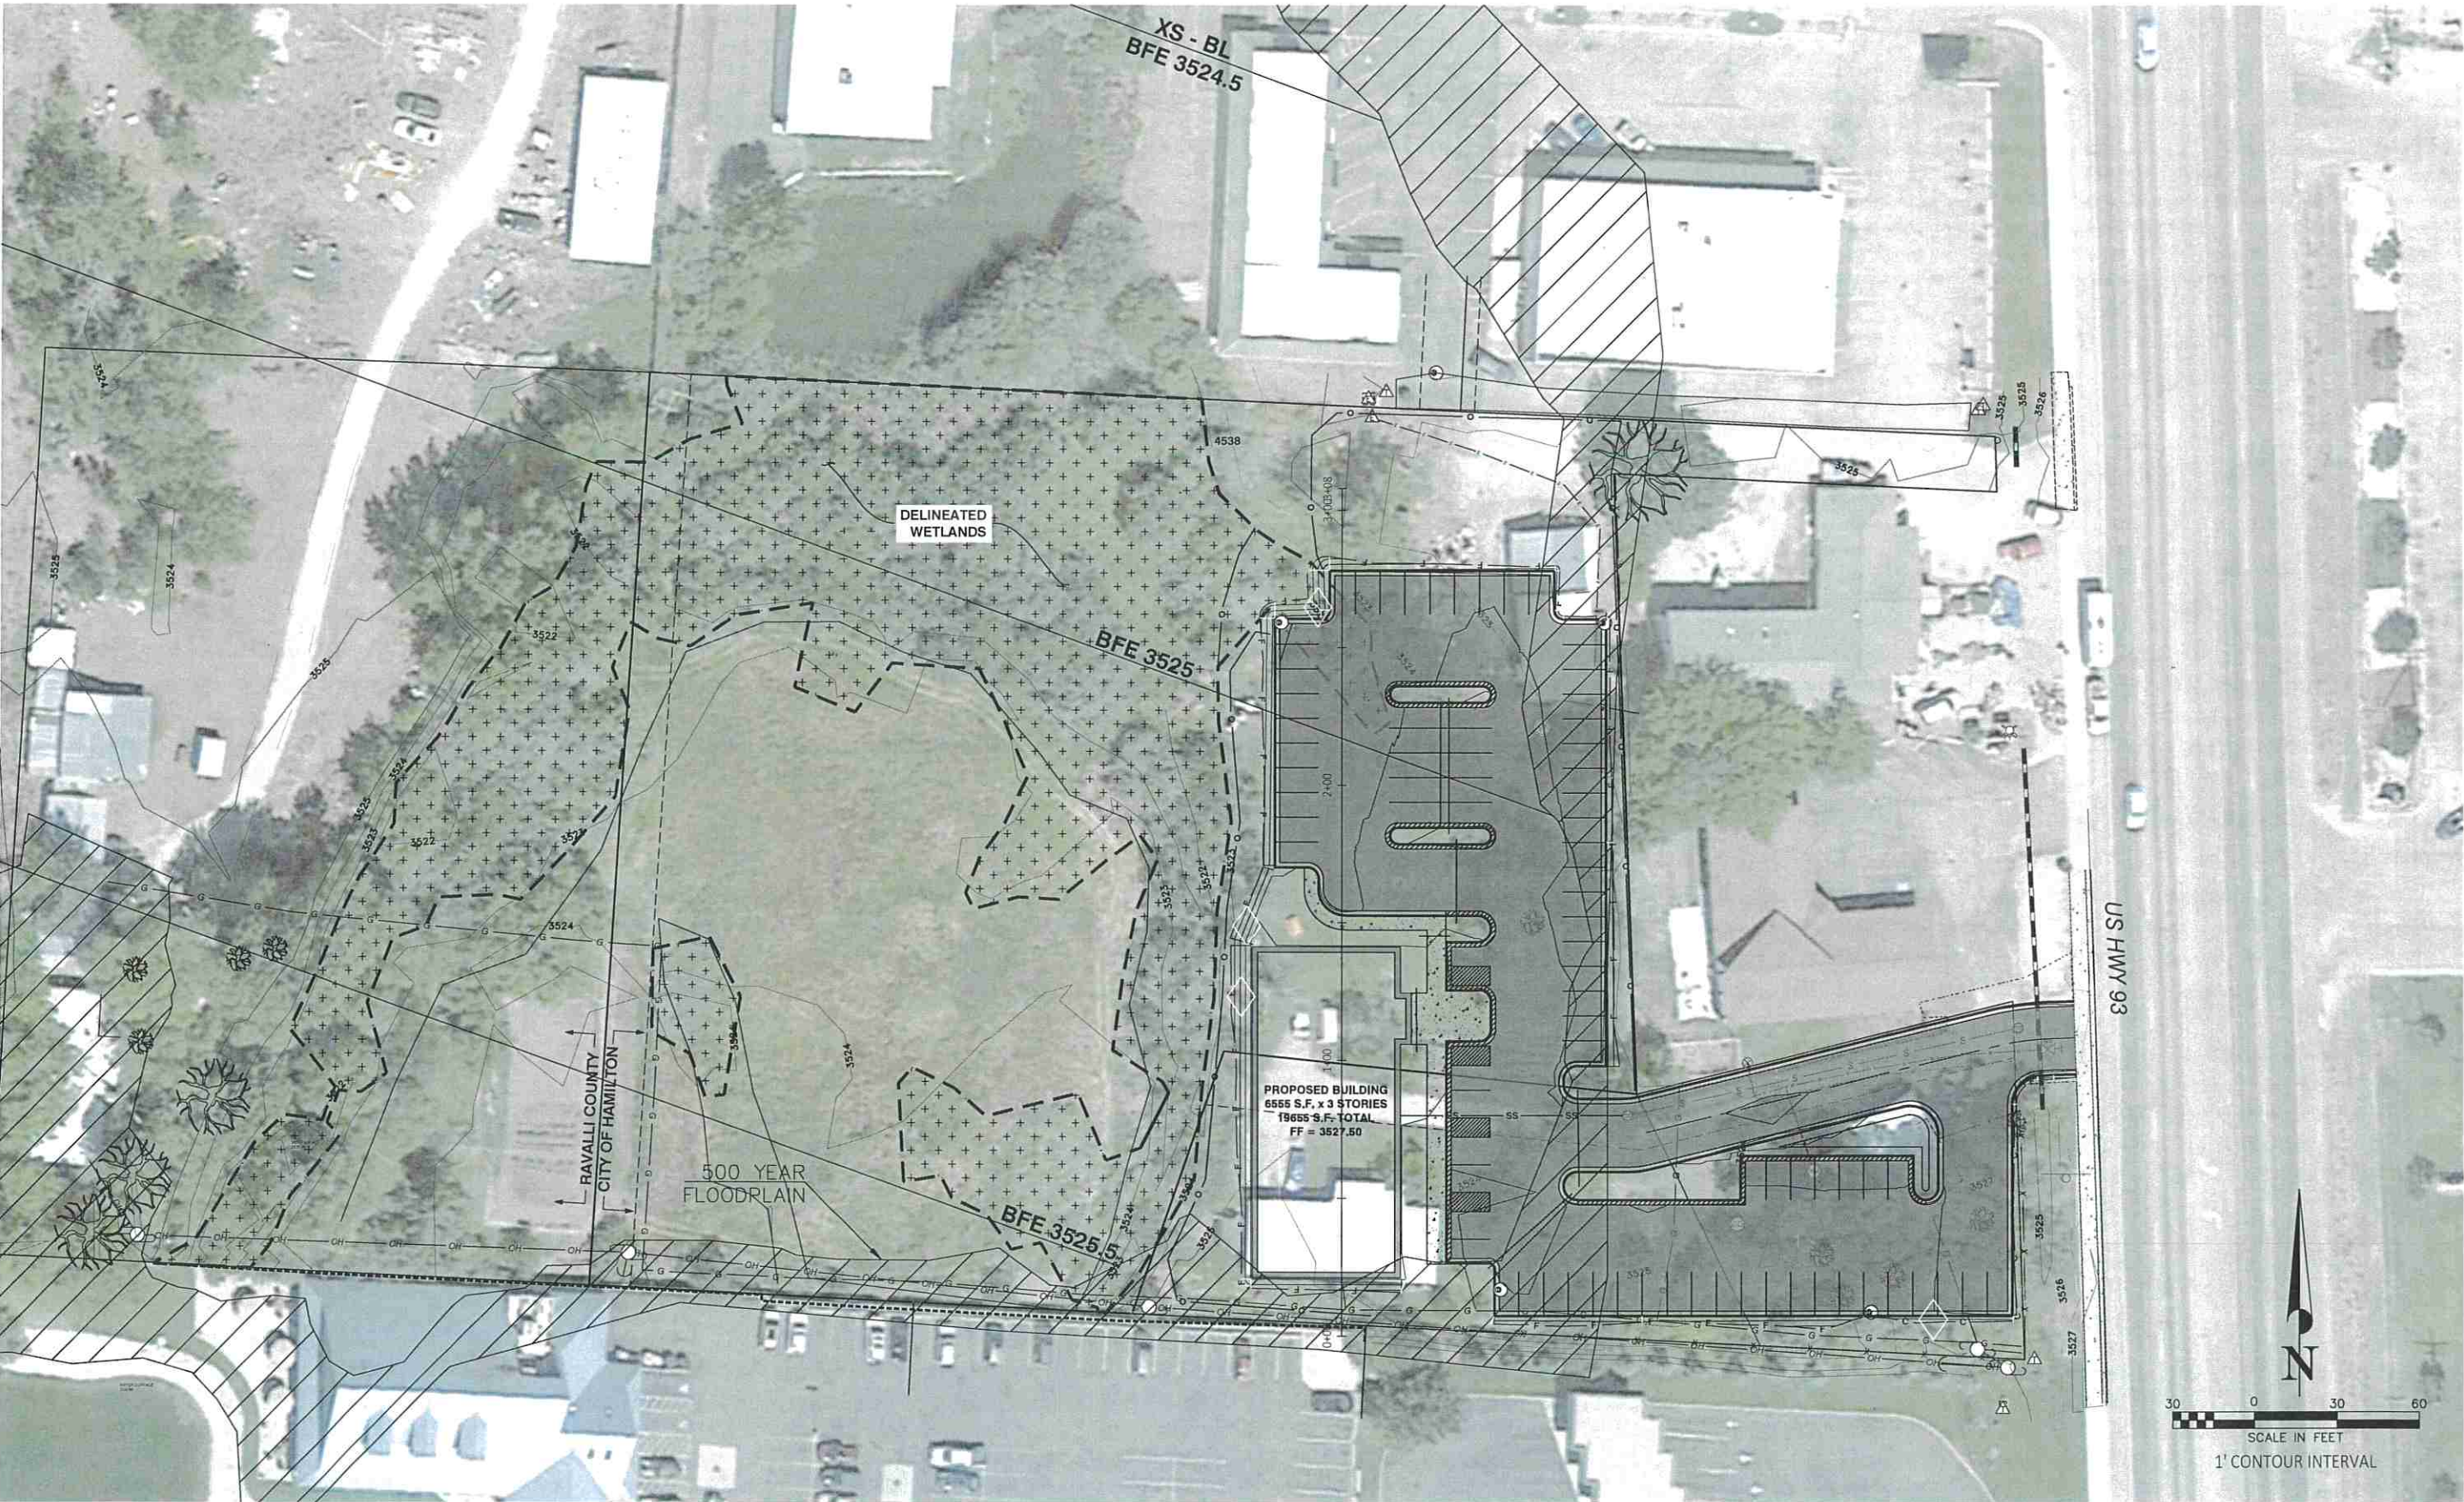
JUNE 2020
SITE
PLAN
C2.1

SAPPHIRE COMMUNITY HEALTH
SITE PLAN

SAPPHIRE COMMUNITY HEALTH
MEDICAL BUILDING
US HWY 93 RAVALLI CO. HAMILTON, MT

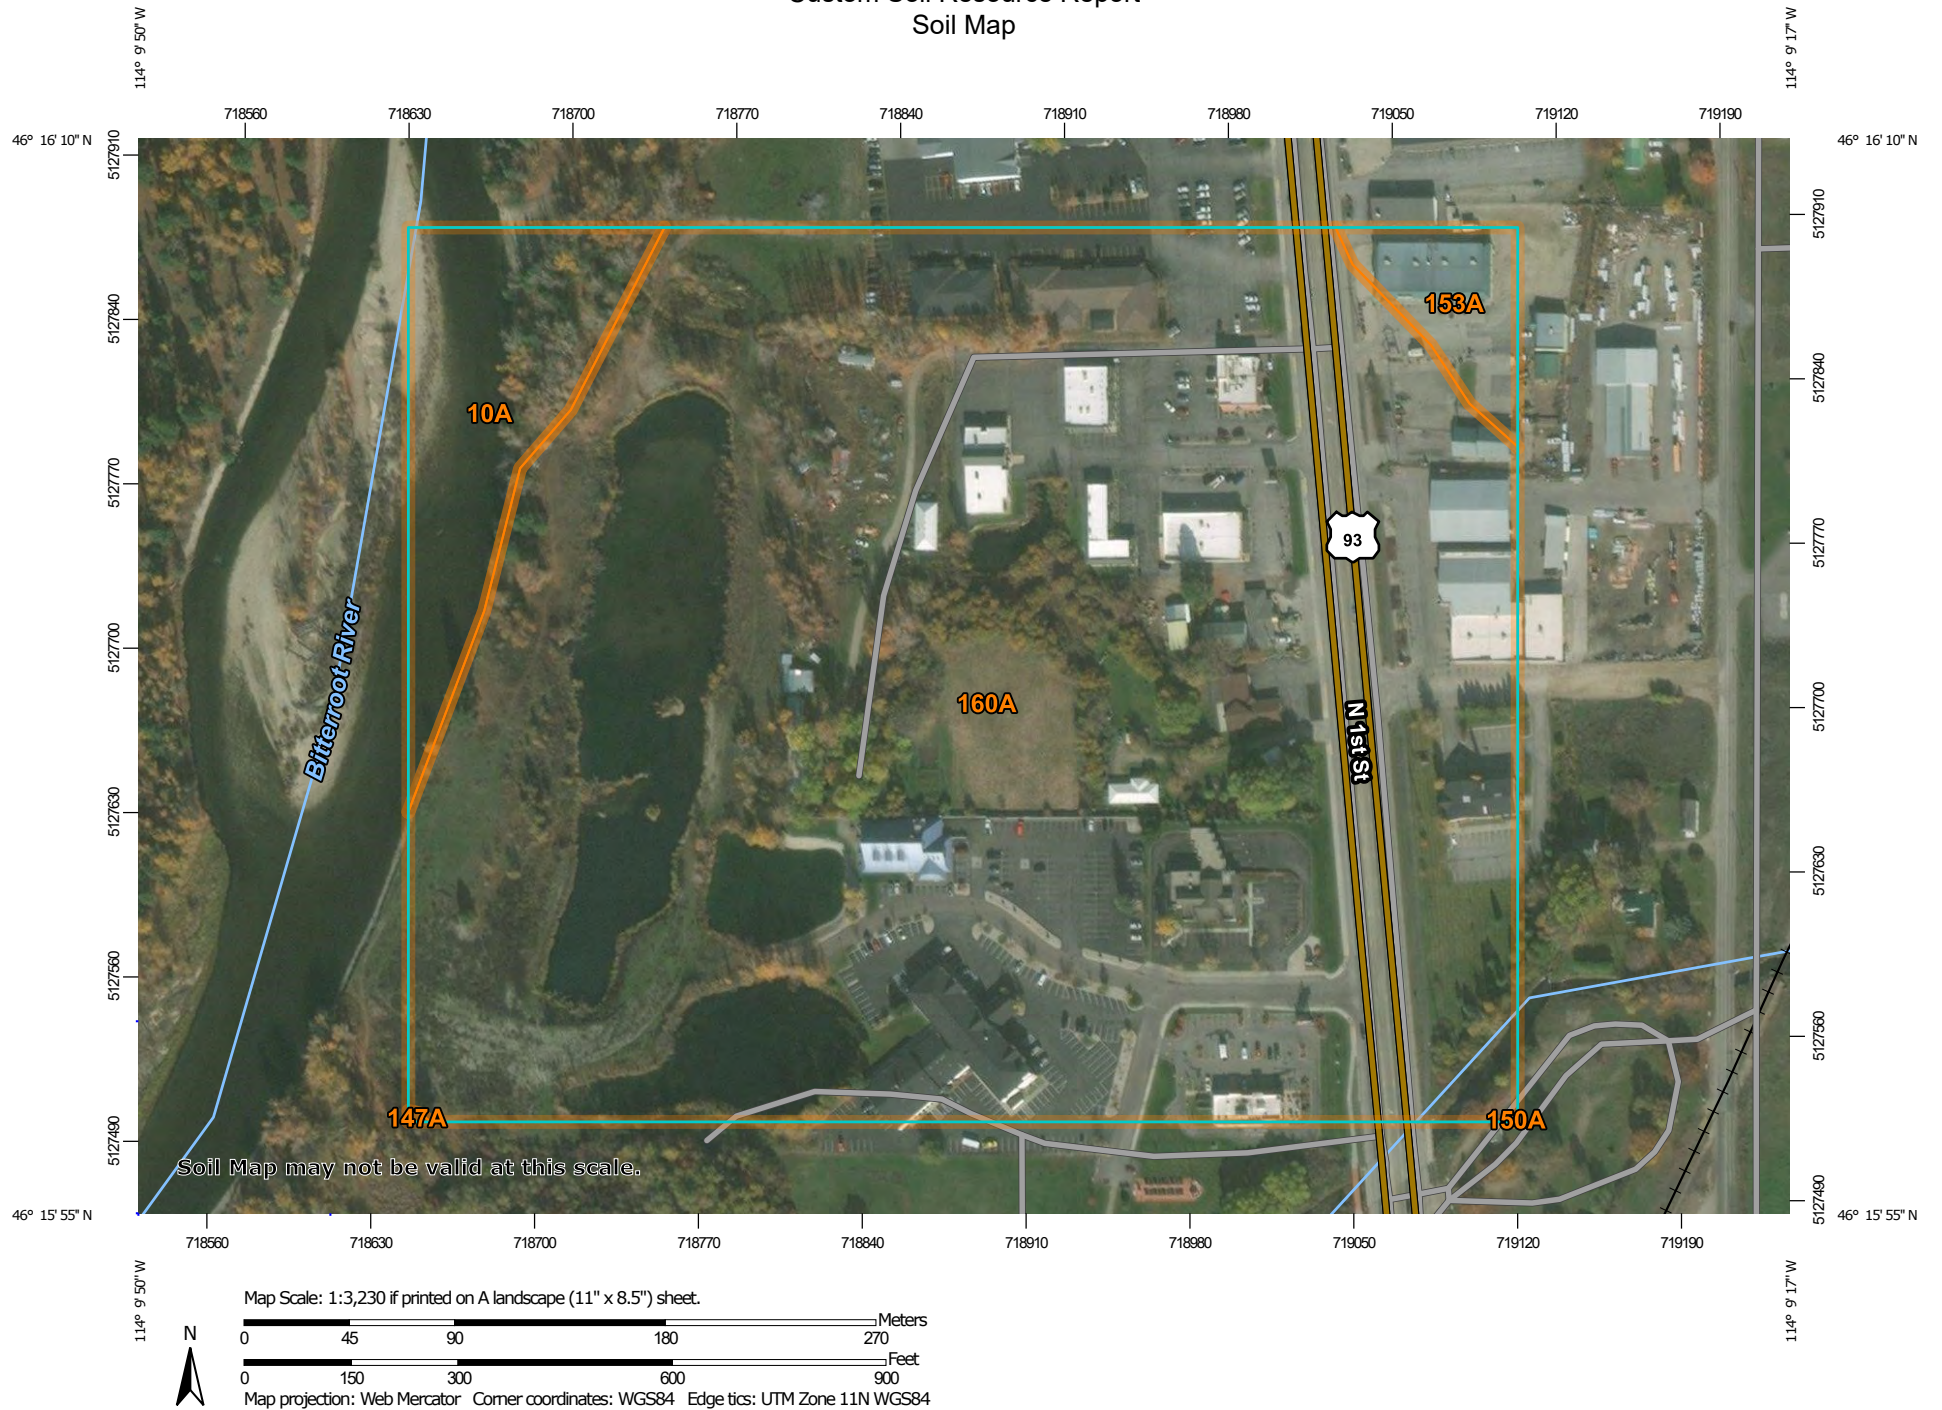
Custom Soil Resource Report Soil Map

The soil map section includes the soil map for the defined area of interest, a list of soil map units on the map and extent of each map unit, and cartographic symbols displayed on the map. Also presented are various metadata about data used to produce the map, and a description of each soil map unit.

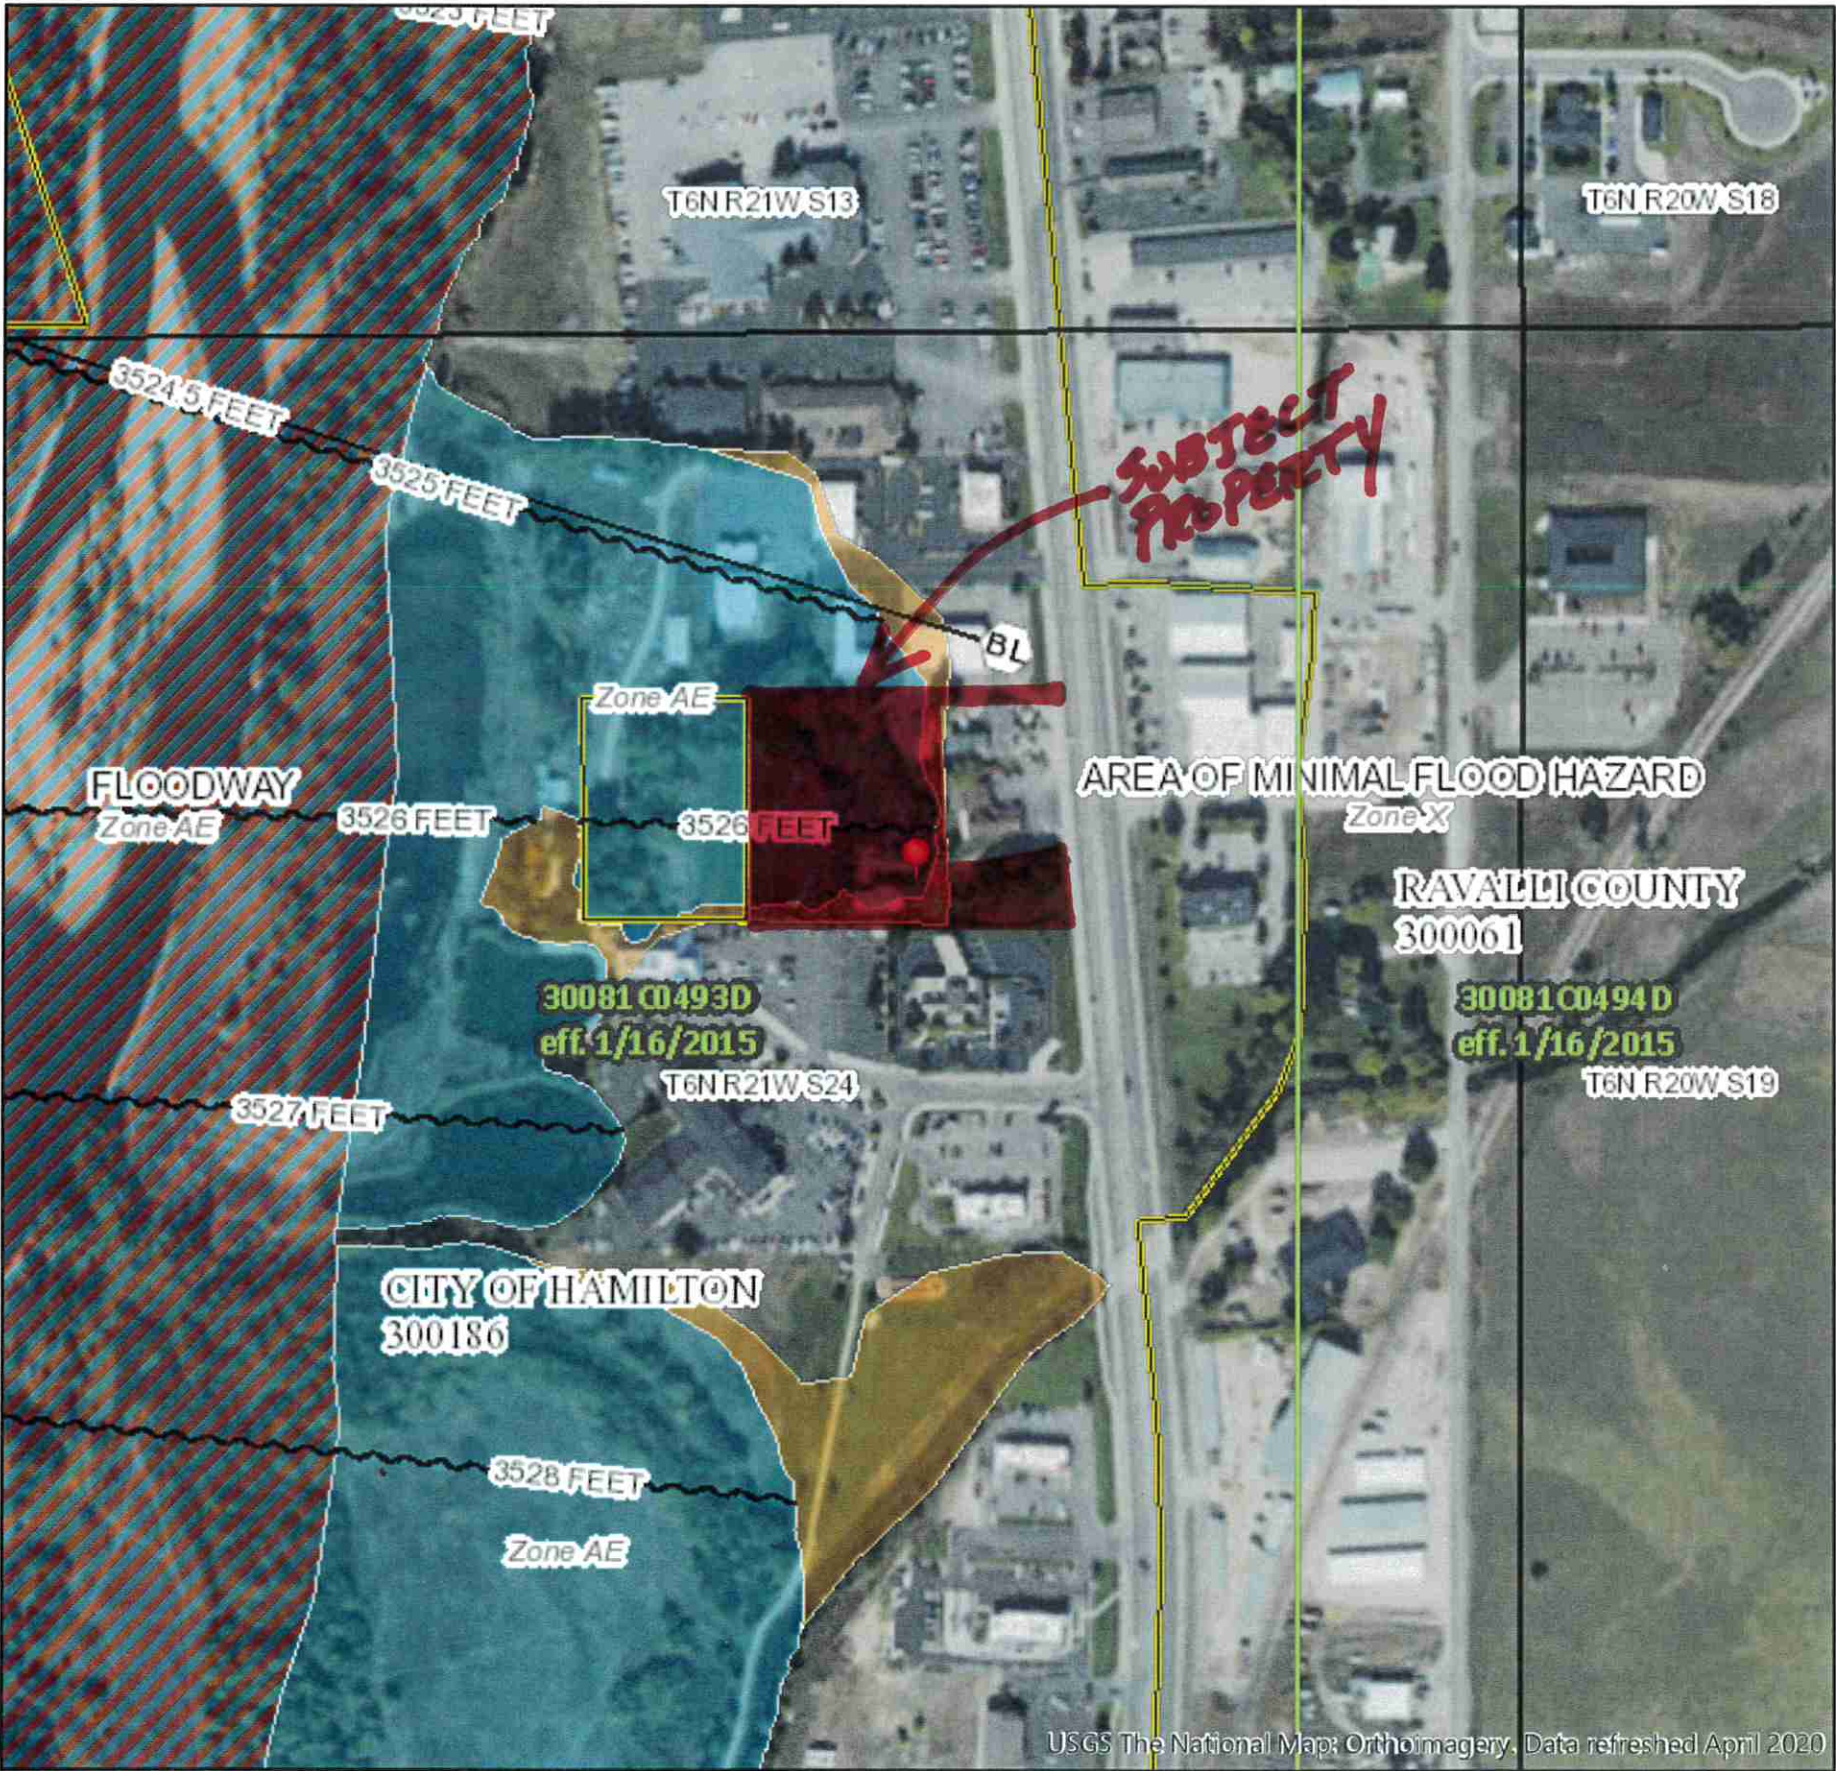
National Flood Hazard Layer FIRMMette

A floodplain map is included in **Appendix 5**. The project site lies outside the Regulated Floodway but within the Special Flood Hazard Area (SFHA) subject to inundation by the 1-percent-annual-chance flood (Zone AE).

The Proposed Action will encroach on a FEMA flood hazard zone. Therefore, SCH will place engineered fill material to raise the building site above the Base Flood Elevation. SCH has applied for and received a Conditional Letter of Map Revision based on placement of fill (CLOMR-F) from the Federal Emergency Management Association (FEMA) for this activity. By this action, FEMA agrees the proposed encroachment will not significantly impact floodplain function. The CLOMR-F application and FEMA approval documentation is included in **Appendix 5**.

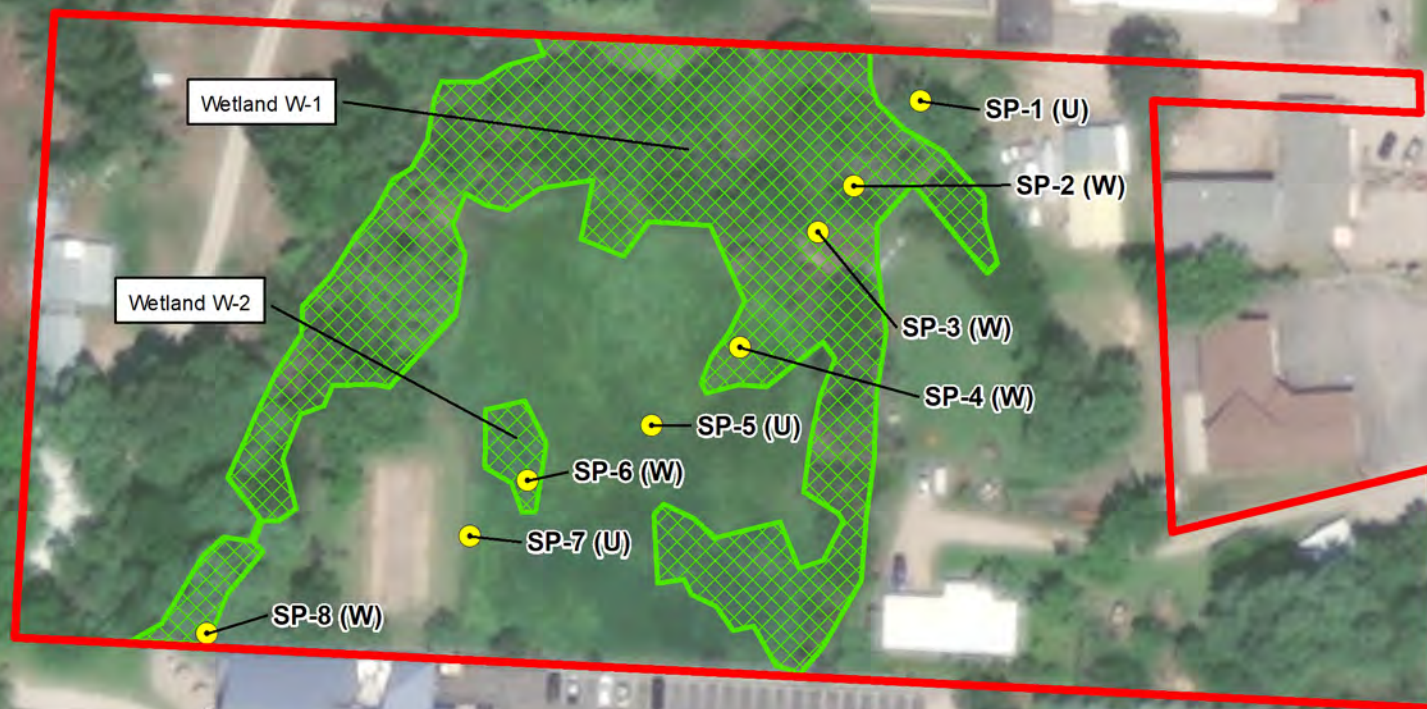
Figure 2
Sapphire Community Health
Wetland Delineation Map

-   Project Area (5 Ac.)
-   Wetland Area (1.09 Ac.)
-   Sampling Points (SP)

The National Wetlands Inventory indicates riparian forest/shrub wetlands (Rp1SS) are present on the project site (see **Appendix 7**). This type of riparian area is dominated by woody vegetation less than 20 feet tall, including tree saplings and trees that are stunted due to environmental conditions. A wetlands determination was performed in May 2020 that included the 3.02-acre project site as well as the 1.7-acre parcel contiguous to the west that is also owned by SCH but not included in this project. The wetlands report is included in **Appendix 7**. The wetlands determination was performed in accordance with appropriate USACE Section 404 wetlands delineation procedures. The conclusion of the wetlands determination is that none of the project site is “jurisdictional” wetlands. Concurrence of the wetlands determination was sought and obtained from the USACE. Copies of the Approved Jurisdictional Determination and No Permit Required letters are included in **Appendix 7**. Based on the wetlands determination and USACE concurrence, no further permit coordination is required.

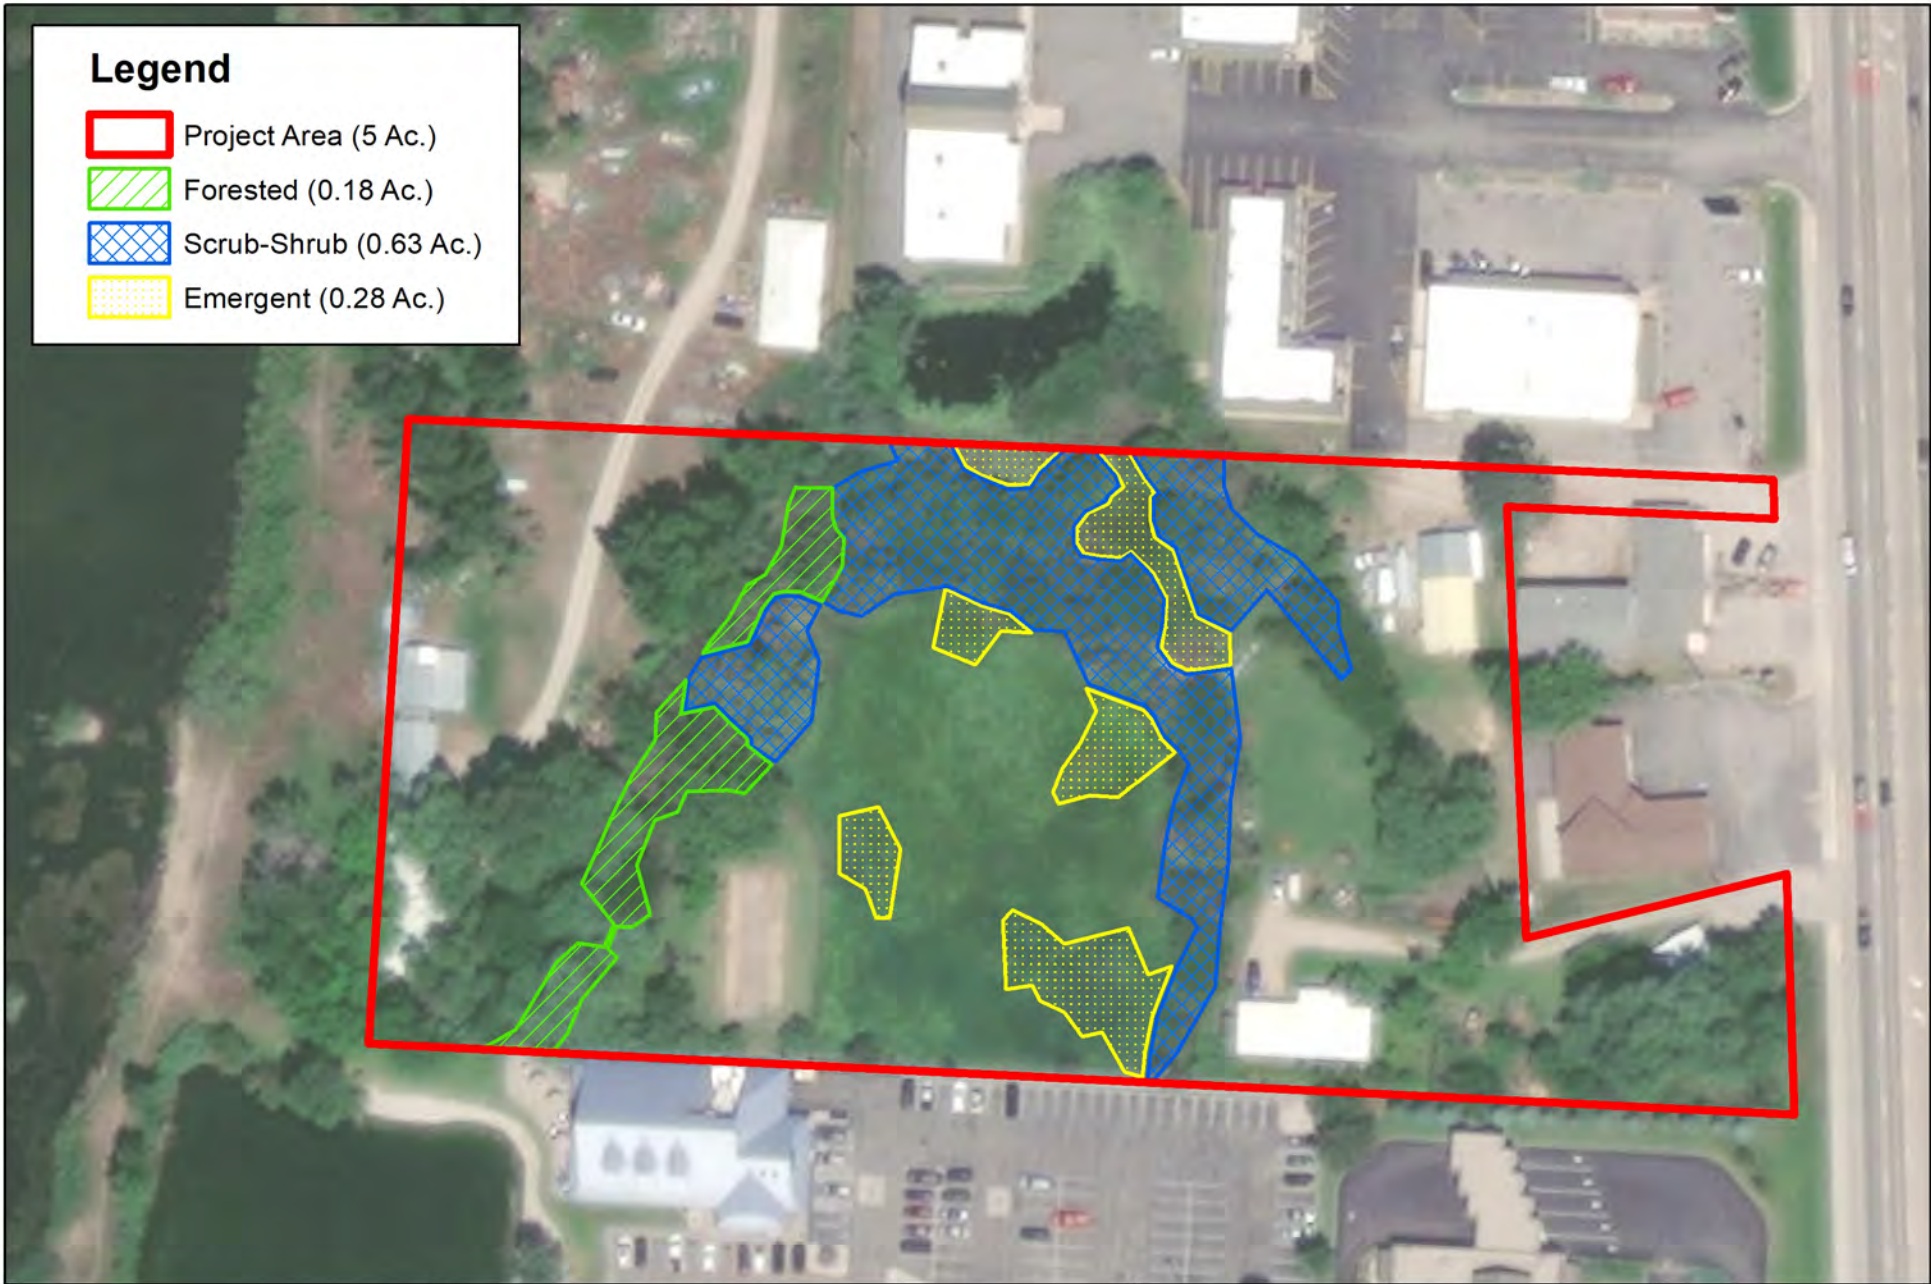
Salix Environmental, LLC 810 Rollins Missoula, MT 59801	Figure 3 Sapphire Community Health Wetland Vegetation Types	Date: May 27, 2020	
		Location: Hamilton, MT	
		0 50 100 200 Feet

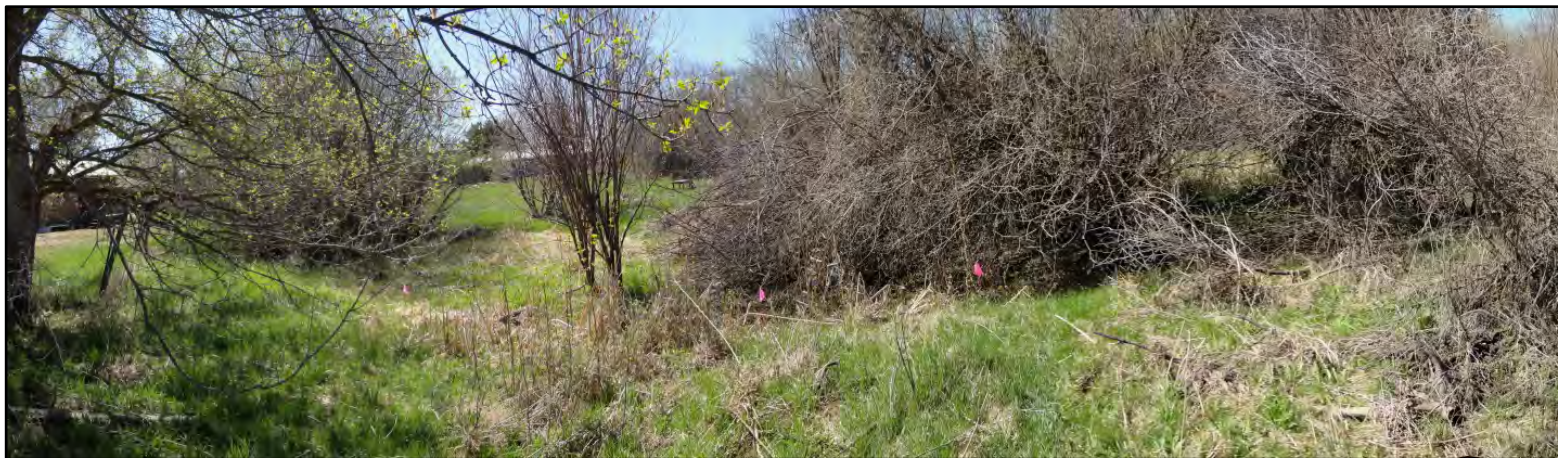
PP1. View looking southwest at upland Sampling Point SP-1 (U) and across adjacent wetland area. Wetland area dominated by emergent and scrub-shrub vegetation types.

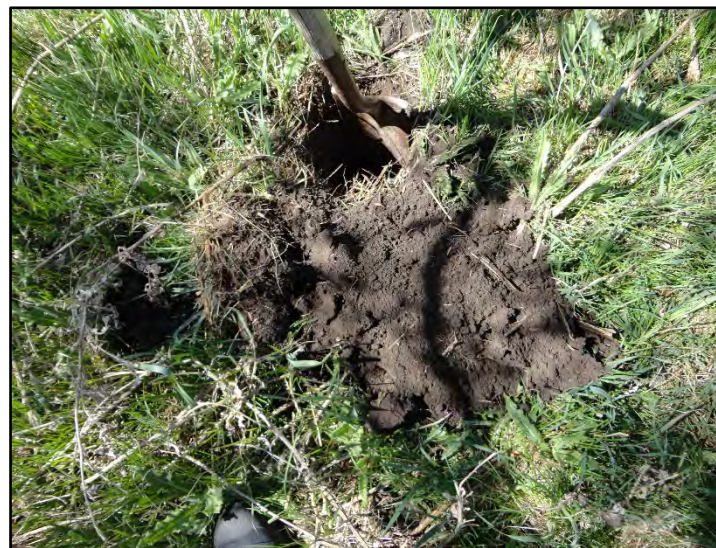
PP1. Sampling Point SP-1 (U) soil pit.

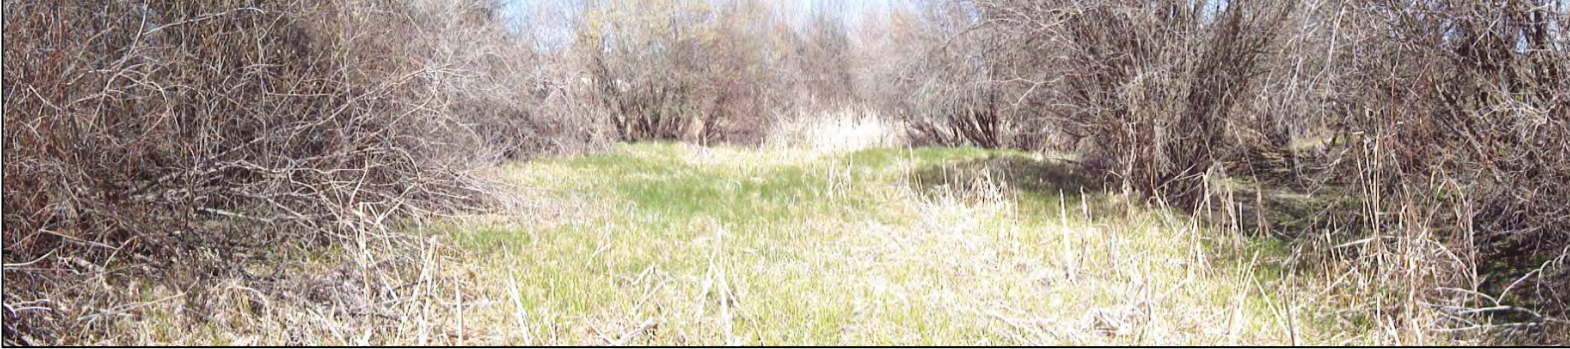
PP2. View looking north across wetland area dominated by scrub-shrub and emergent vegetation types.

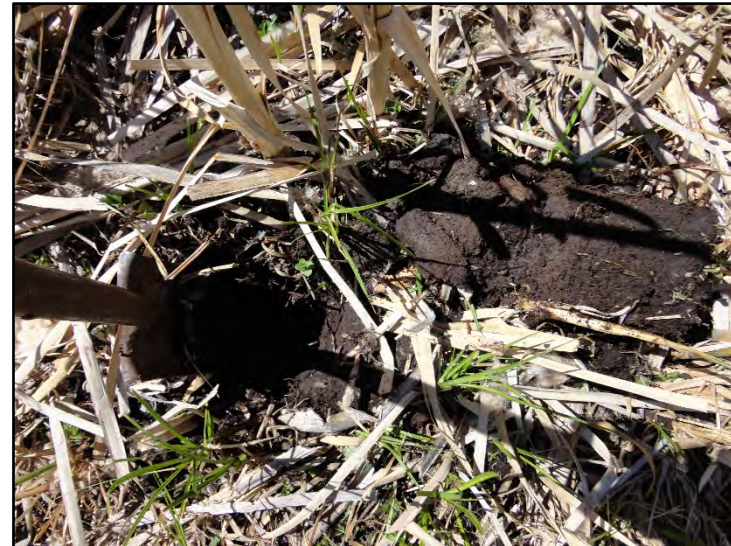
PP2. View looking at Sampling Point SP-3 (W) soil profile.

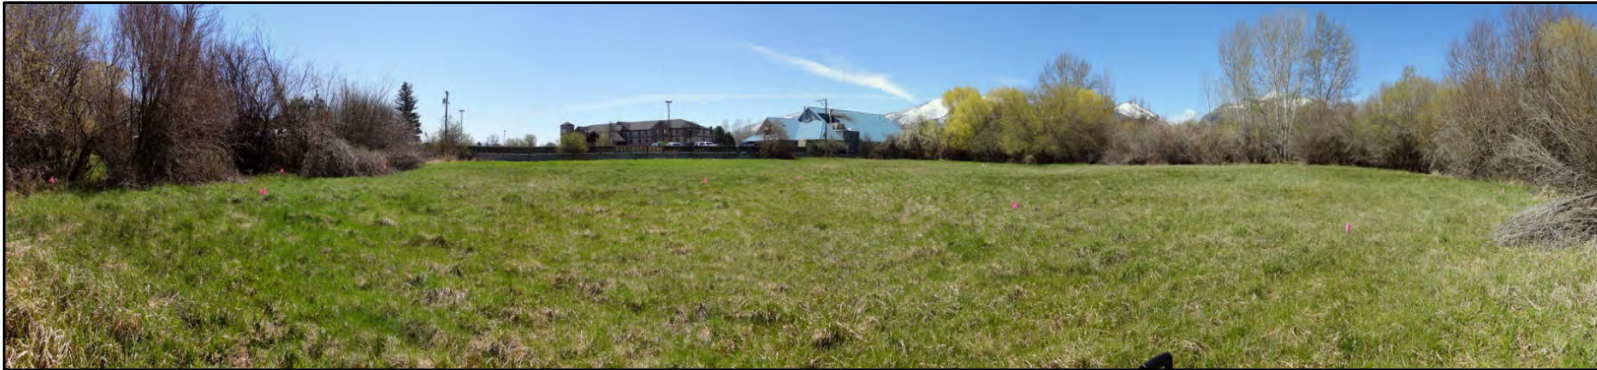
PP5. View looking southwest across open meadow dominated by wetlands around the fringe and upland in the center. Several pockets of wetland emergent vegetation type encroach into the meadow.

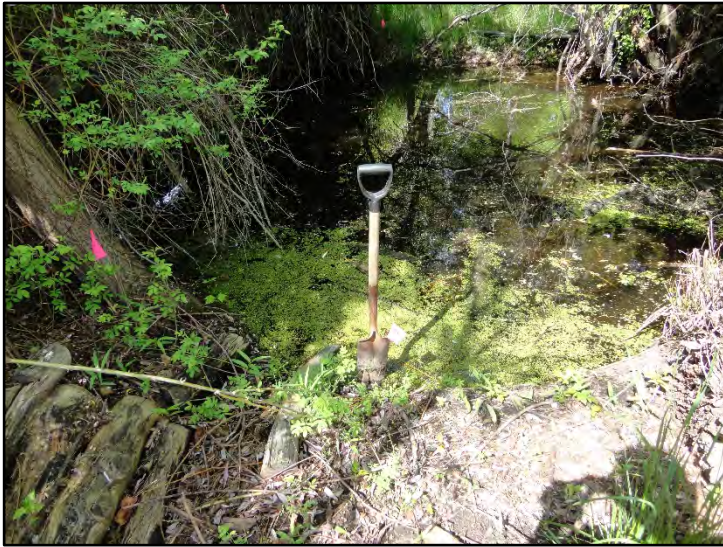
PP9. View looking at Sampling Point SP-8 (W). Wetland area consists of shallow depression with surface water and has wetland vegetation growing along the fringe.

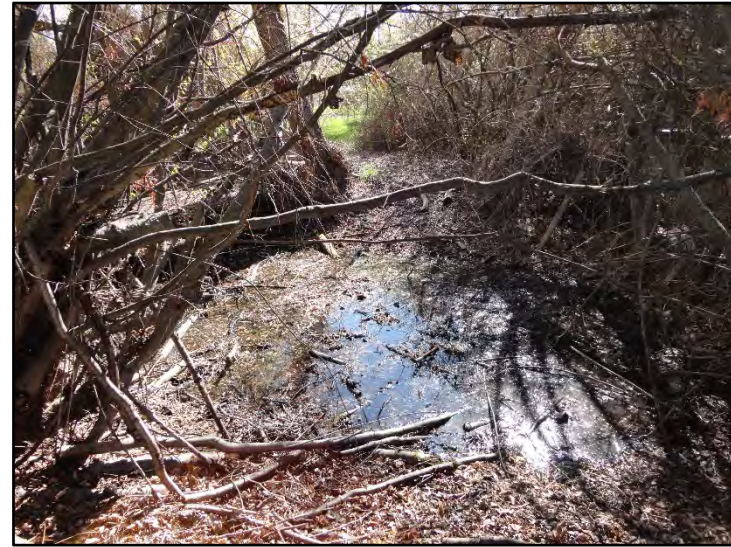
PP10. View looking east across the wetland. Sampling Point SP-8 (W) located on the far side of the depression. Area dominated by forested, emergent and aquatic bed vegetation types.

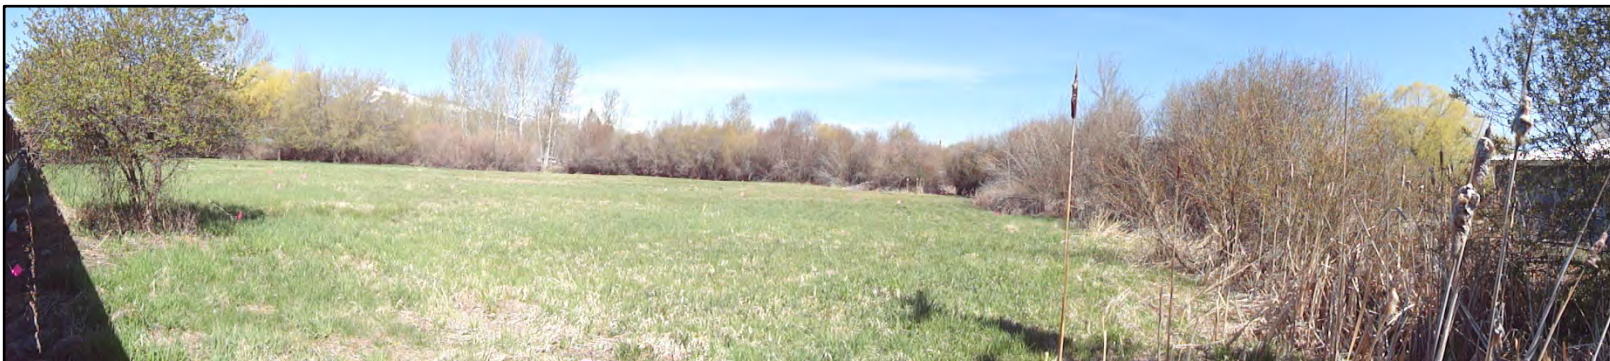
PP11. View looking north across the meadow from the southern boundary. Wetlands located along the east side of the meadow with fringe of emergent vegetation encroaching into the meadow.
